RECALL NOTIFICATION

September 2, 2016

Re: Murray Helm Chair Assembly - Viking Part Nos. VP#624558 VP#624639 and VP#624641

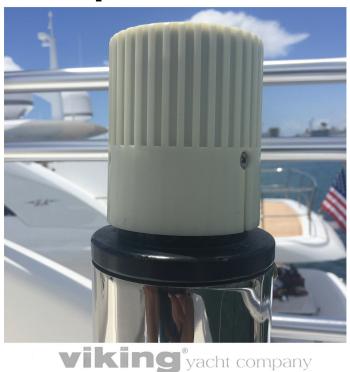
Does the top of your helm chair pedestal look like this? Then please read below:

Viking Yacht Company has been notified that the above described component may be defective. The defect in the fabrication of the bushing linking the chair to the pedestal may result in the bushing breaking off completely, causing the occupant of the chair to be ejected. If the Murray chairs have been installed in helm, the ejection may cause the occupant to fall onto the deck below. Because of the nature of the installation, in which the chair base covers the bushing, damage or deflection to the bushing will not be visible. The breaking can occur suddenly and without notice. If the breaking occurs while the boat is underway, additional serious injury may occur. These Murray pedestals were installed on Viking Yachts between 2005 and 2013

THE MURRAY CHAIRS SHOULD NOT BE USED UNTIL THEY HAVE BEEN INSPECTED AND REPAIRED. IF YOU NOTICE ANY WOBBLE IN THE CHAIR OR IF THE PEDESTAL SEEMS CURVED, THESE ARE INDICATORS THAT THE BUSHING MAY BE WEAKENING.

Viking Yacht Company will replace or repair the part or any defective components at no cost to the owner.
